DEPARTMENT OF TRANSPORTATION

Quality Assurance and Source Inspection

Contract #: 04-0120F4Cty: SF/ALA Rte: 80 PM: 13.2/13.9File #: 69.28**WELDING INSPECTION REPORT****Resident Engineer:**Siegenthaler, Peter**Address:** 333 Burma Road**City:** Oakland, CA 94607**Report No:** WIR-017397**Date Inspected:** 03-Oct-2010**Project Name:** SAS Superstructure**OSM Arrival Time:** 700**Prime Contractor:** American Bridge/Fluor Enterprises, a JV**OSM Departure Time:** 1900**Contractor:** Zhenhua Port Machinery Company, Ltd (ZPMC), Changxing Island **Location:** Shanghai,China**CWI Name:** Mr.Xu Tao/Li yun hua**CWI Present:** Yes No**Inspected CWI report:** Yes No N/A**Rod Oven in Use:** Yes No N/A**Electrode to specification:** Yes No N/A**Weld Procedures Followed:** Yes No N/A**Qualified Welders:** Yes No N/A**Verified Joint Fit-up:** Yes No N/A**Approved Drawings:** Yes No N/A**Approved WPS:** Yes No N/A**Delayed / Cancelled:** Yes No N/A**Bridge No:** 34-0006**Component:** OBG**Summary of Items Observed:**

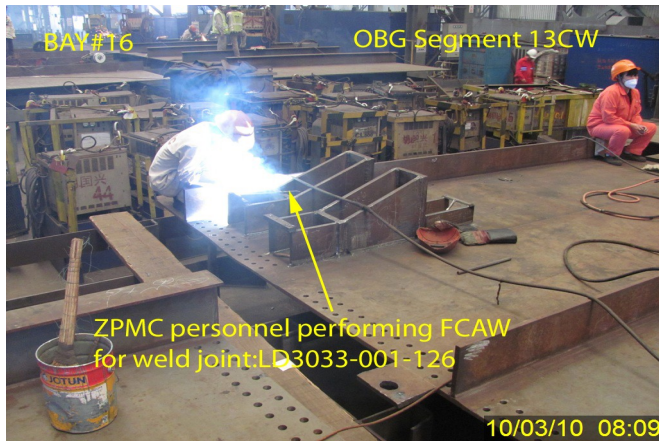
FCAW in the 3G position for the OBG Segment 13CW, weld No: LD3033-001-126. The welder is identified as #045280. ABF QA is identified as Mr. Zou Lui Hai. The welding variables recorded by QC appear to comply with WPS-B-T-2233-TC-U5-F. Please see the attached picture.

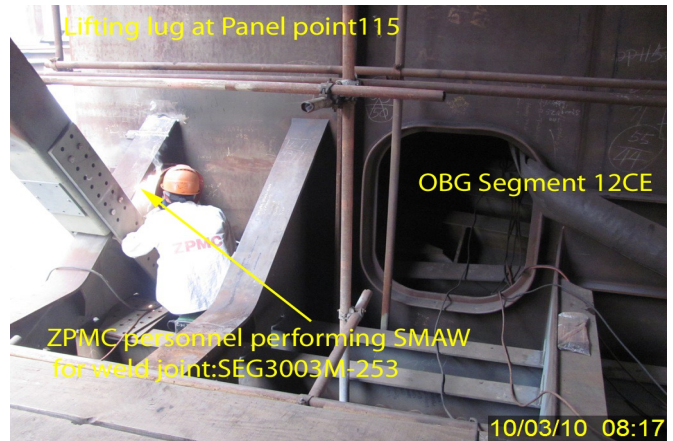
SMAW in the 4G position for the OBG Segment 12CE Lifting lug at Panel point 115, weld No: SEG3003M-253. The welder is identified as #043661. ZPMC QC is identified as Mr. Li ping. The welding variables recorded by QC appear to comply with WPS-B-P-2214-TC-U4b-FCM-1. Please see the attached picture.
